St. Clair River Shoreline Restoration Report

Table of Contents

1.0 Introduction

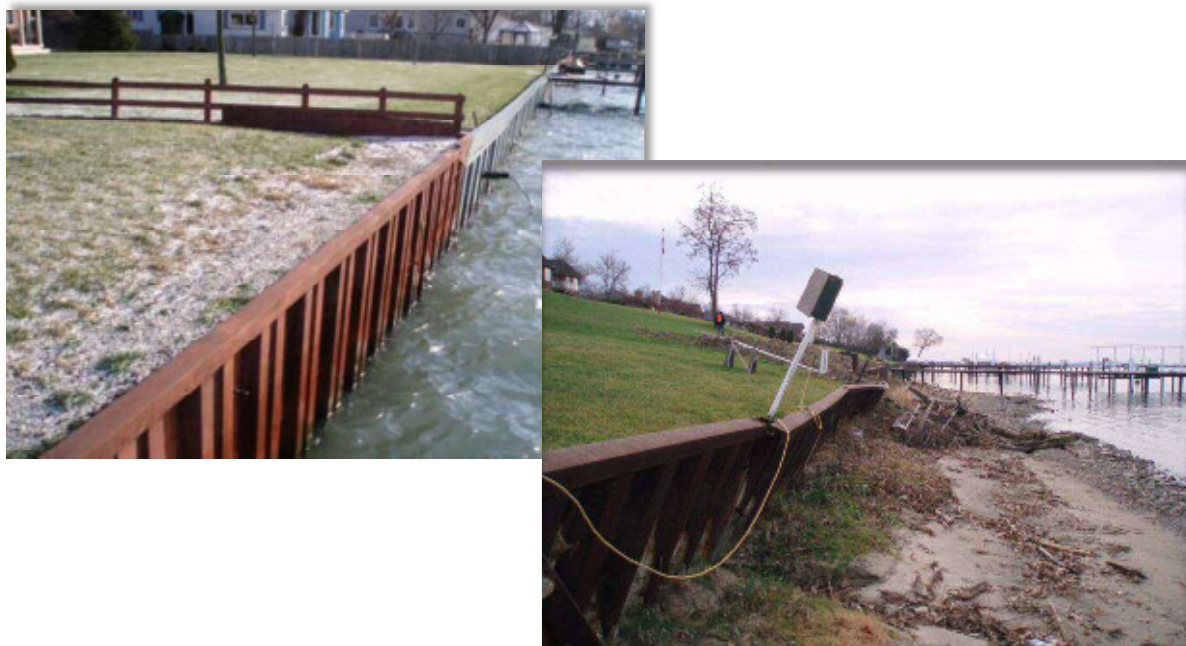
Figure 2 Typical bulkheads/seawalls along St. Clair River

The most common types of shoreline structure encountered in this study were **bulkheads/seawalls**, which were given the same classification. They cover approximately **28** kilometers of the study area. Concerns have been raised that bulkheads and seawalls have led to artificial straightening and hardening of shorelines, and gradual infilling of waters along the St. Clair River, with a loss of valuable fish habitat and natural shoreline contours and landscapes. They are most often found along residential properties and in industrial areas, and are mainly composed of steel (Figure 2). Problems arise with bulkheads when water is able to penetrate through the structure. If the structure was not installed or designed correctly, erosion will occur behind the wall and will lead to flanking and failure of the toe.

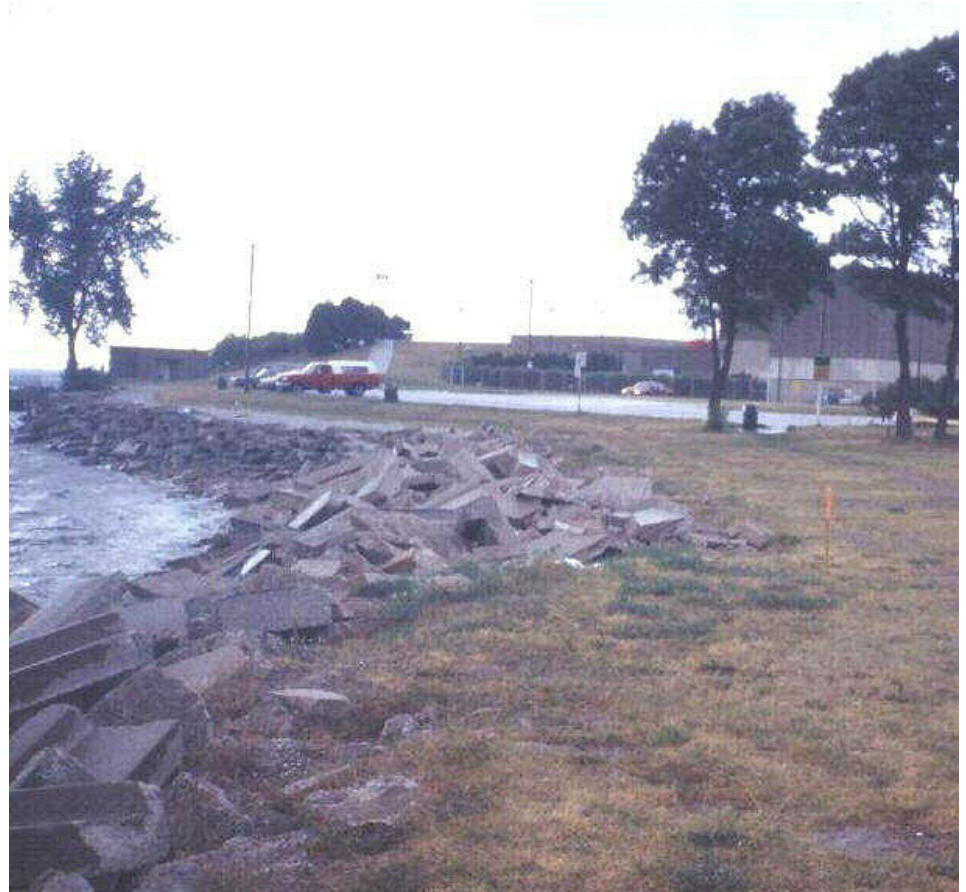
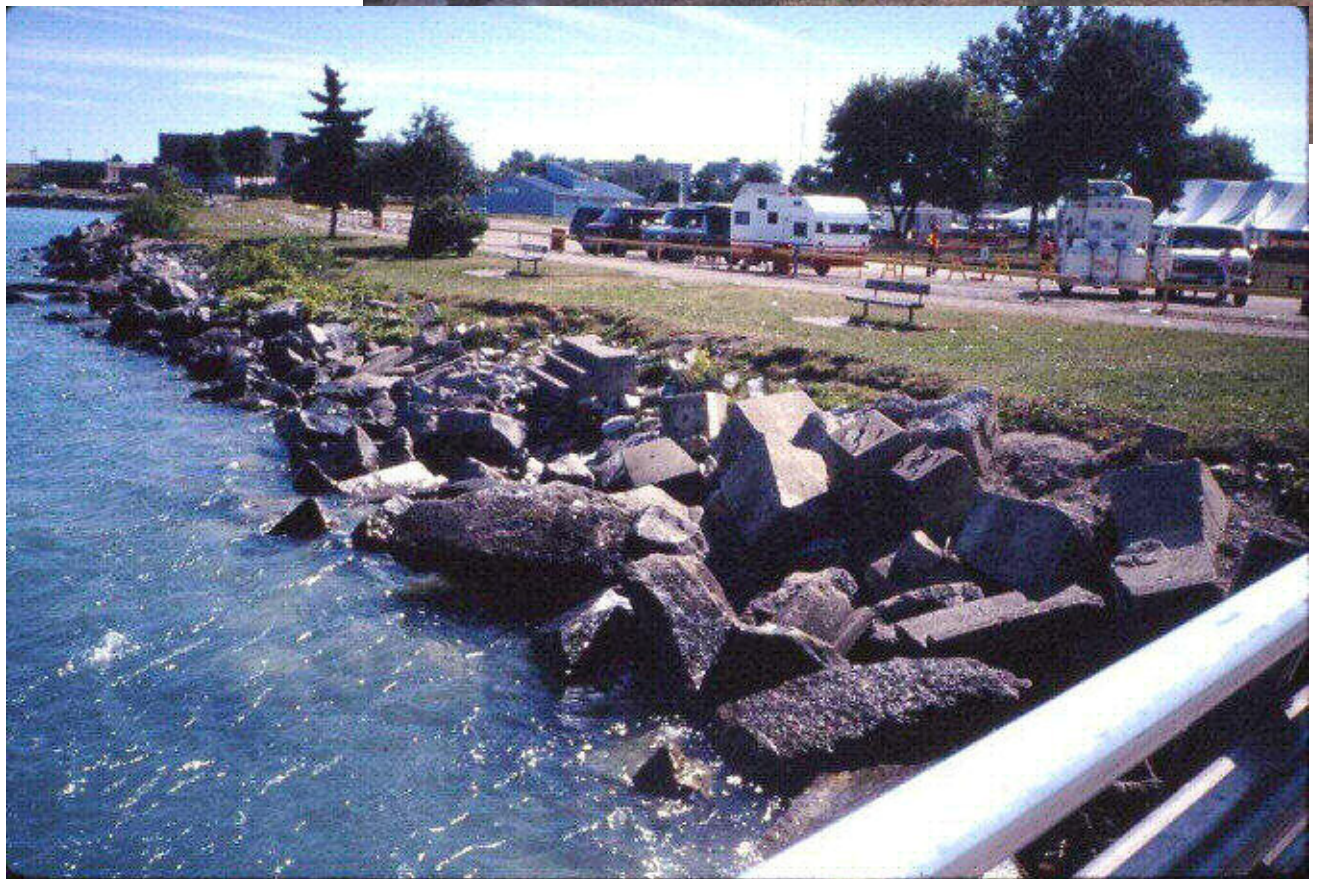
Point Edward Erosion Control Project

**Prior to protection
improvements**

The work included removals of randomly stacked, discarded concrete, supply and placement of rip rap, armour stone and geotextile and other general site work associated with the construction of approximately 265 metres of a revetment and stepped revetment. Before and after construction pictures are provided below along with the location of the site.

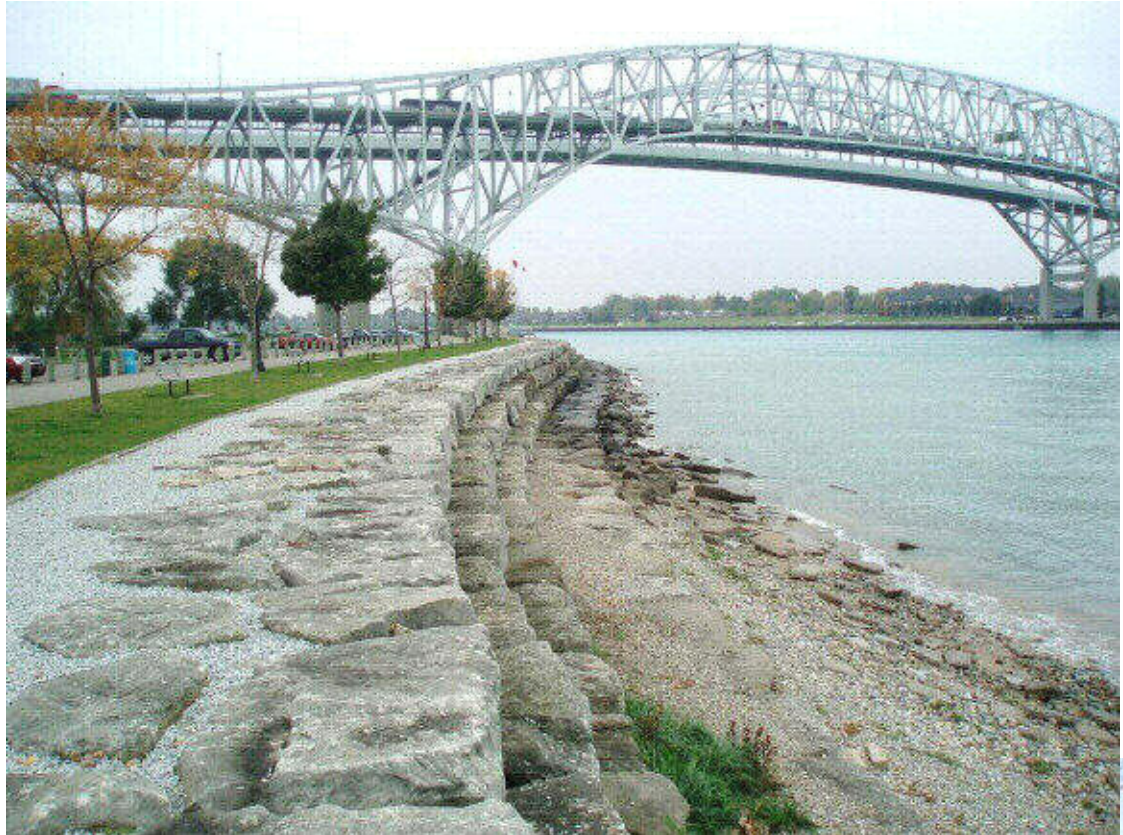
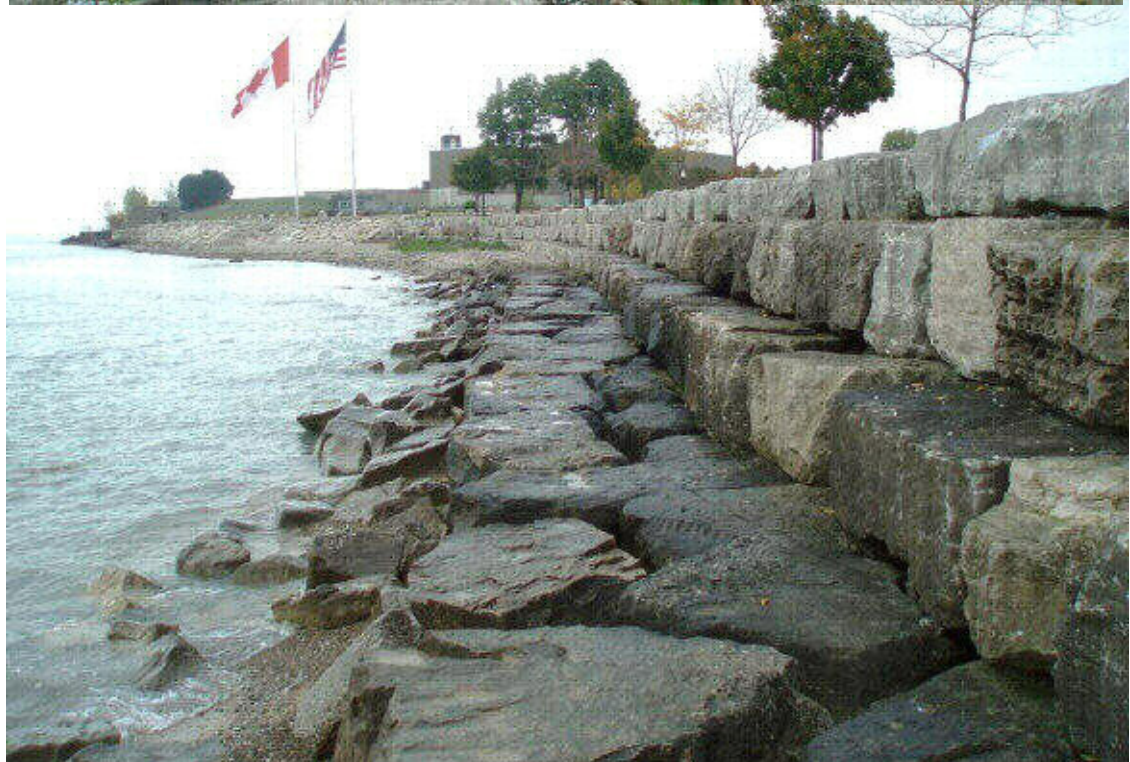
After Protection Improvements

Top – stepped armour stone protection

Bottom – water's edge access

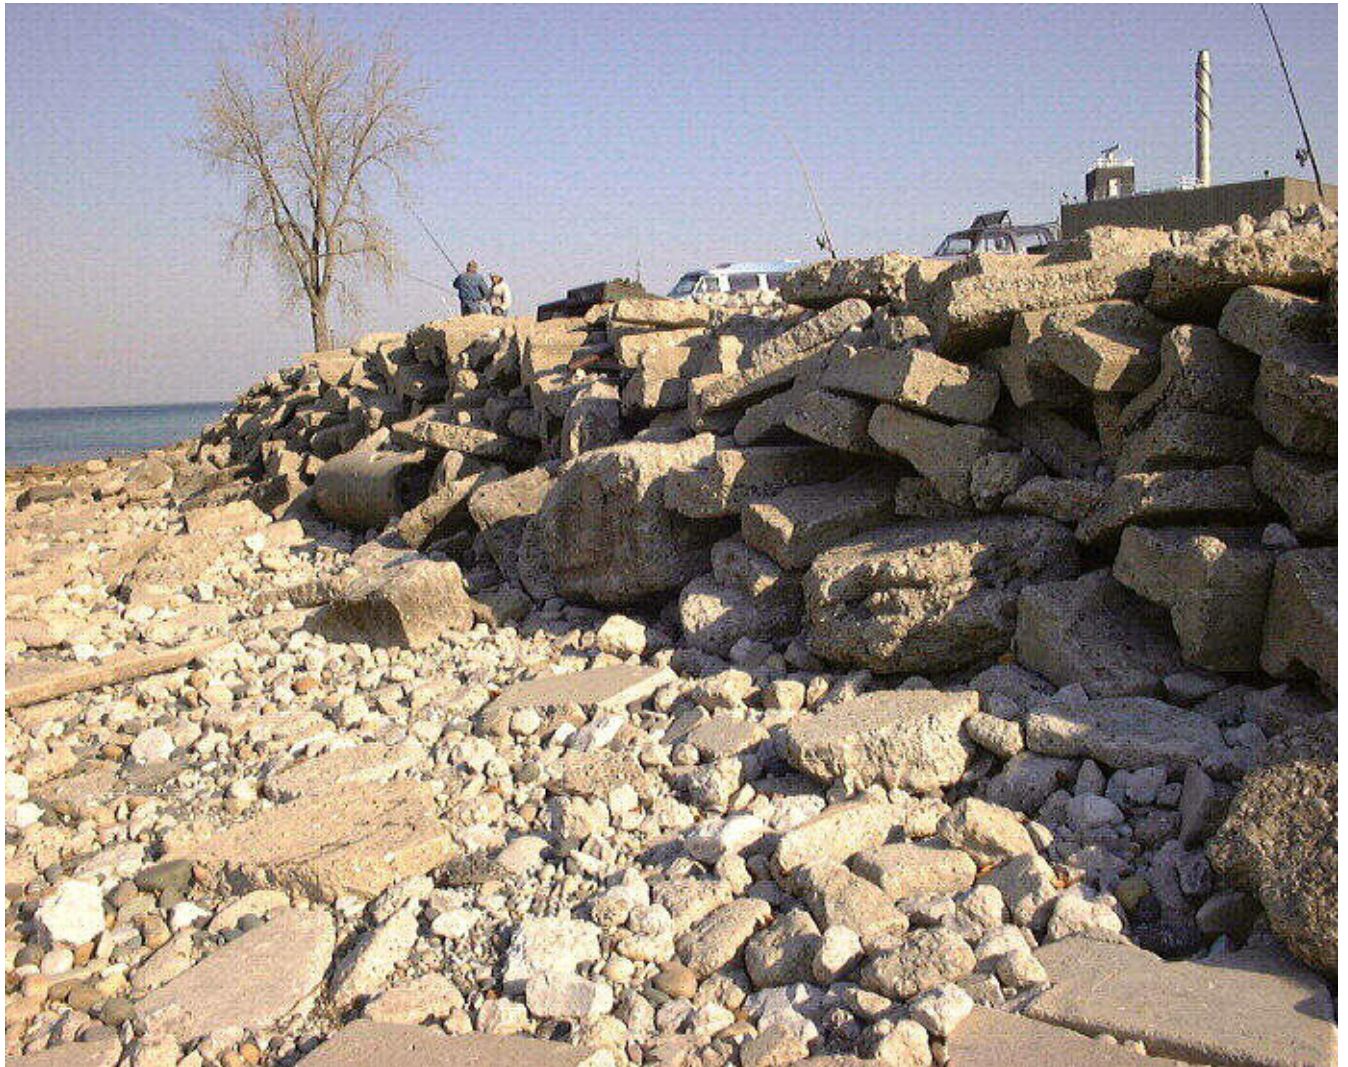
Lambton Area Water Supply System Erosion Control Project

Prior to protection improvements

The work included removals of existing structures, supply and placement of rip rap, armour stone and geotextile and other general site work associated with the construction of approximately 110 metres of a revetment and stepped revetment.

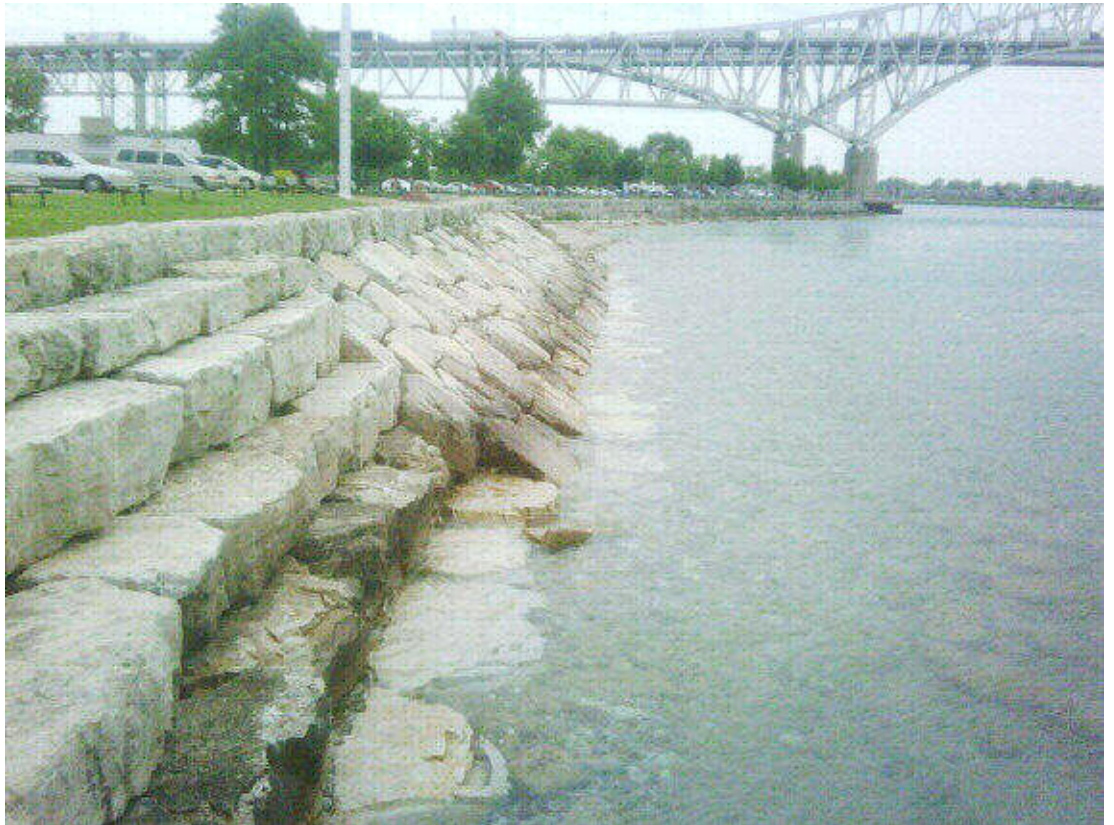
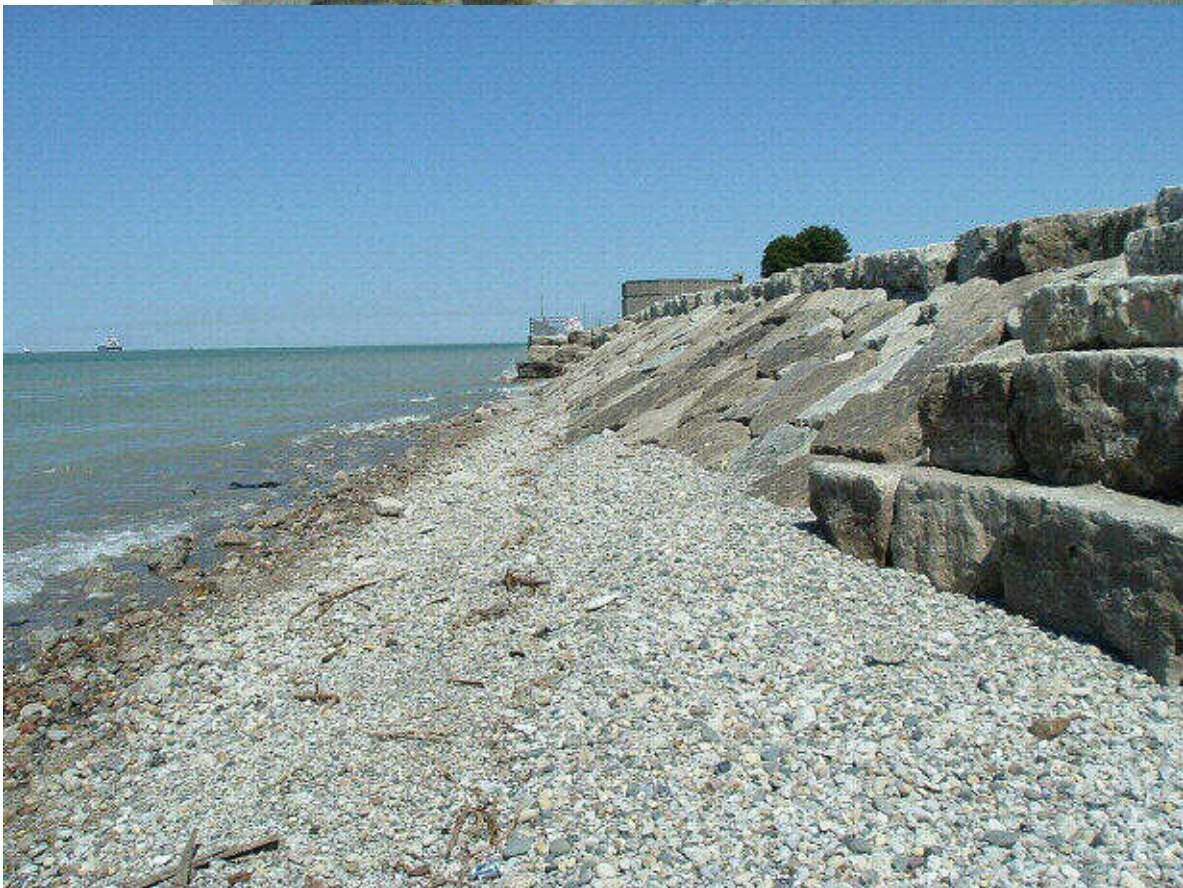
After Protection Improvements

Top –
stepped &
sloped
armour
stone
protection

Bottom –
along cobble
beach

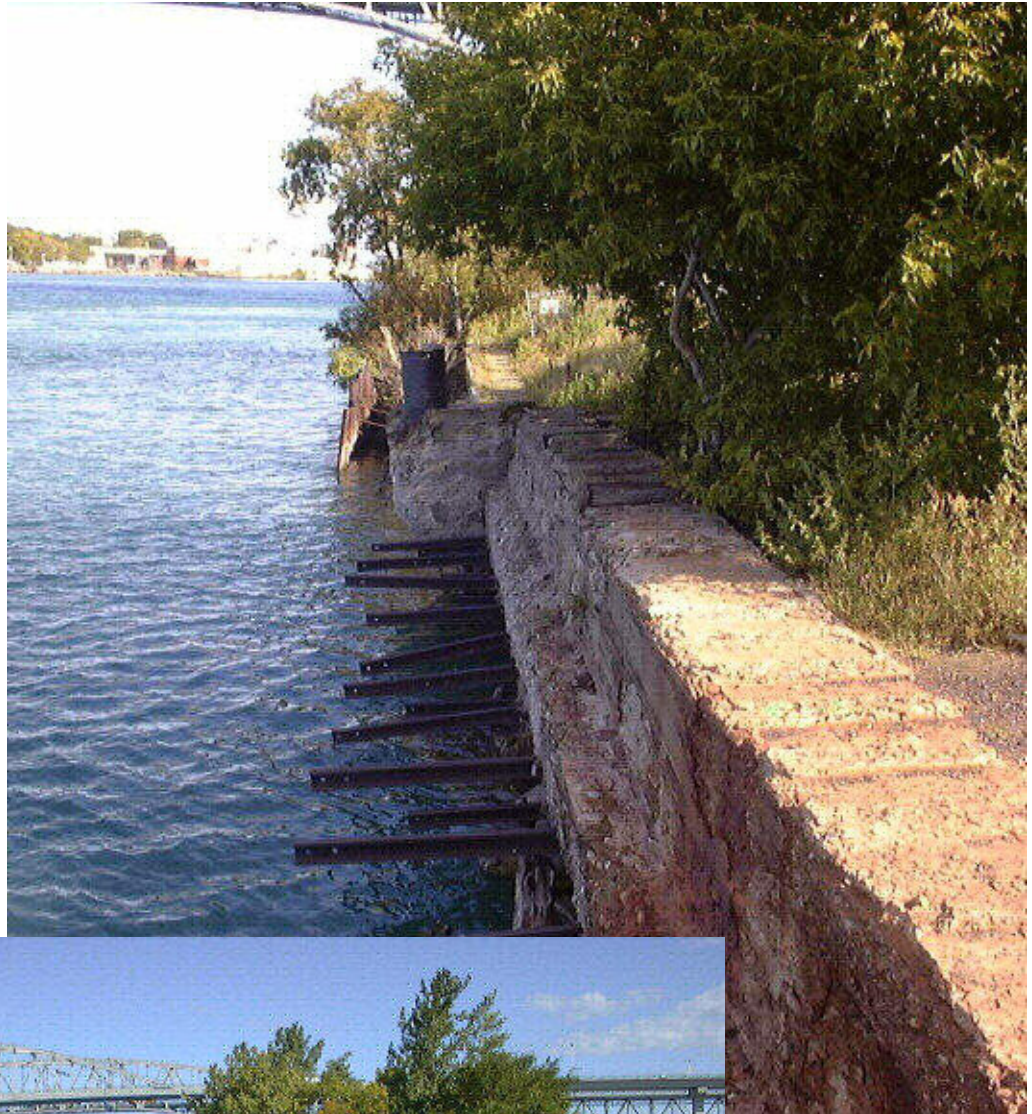
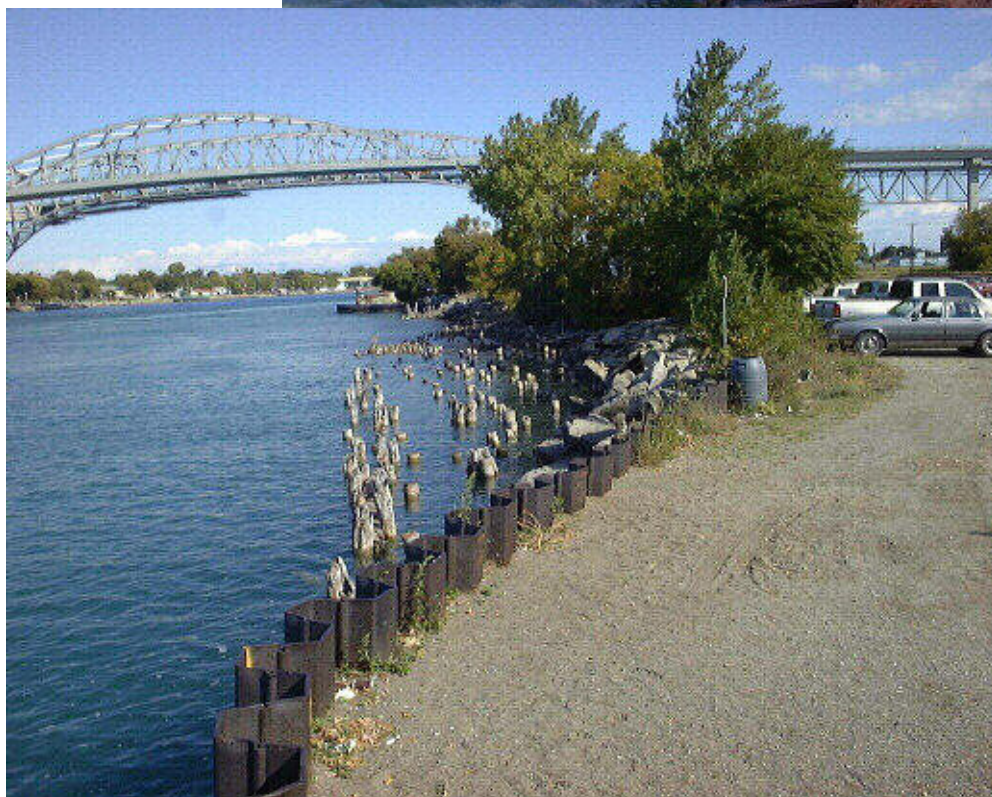
**Point Edward
Waterfront
Shore
Protection
Project**

**Prior to
protection
improvements**

Phase 2 work provided shoreline protection to about 260 meter of St.Clair River shoreline, this work was completed in 2007.

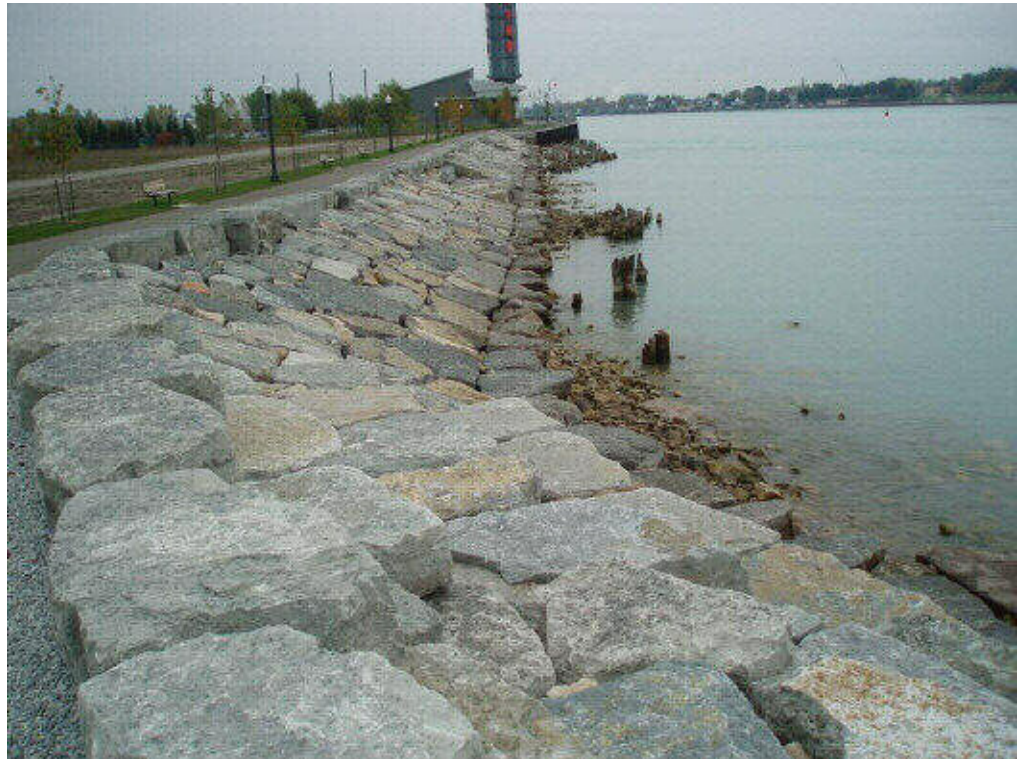
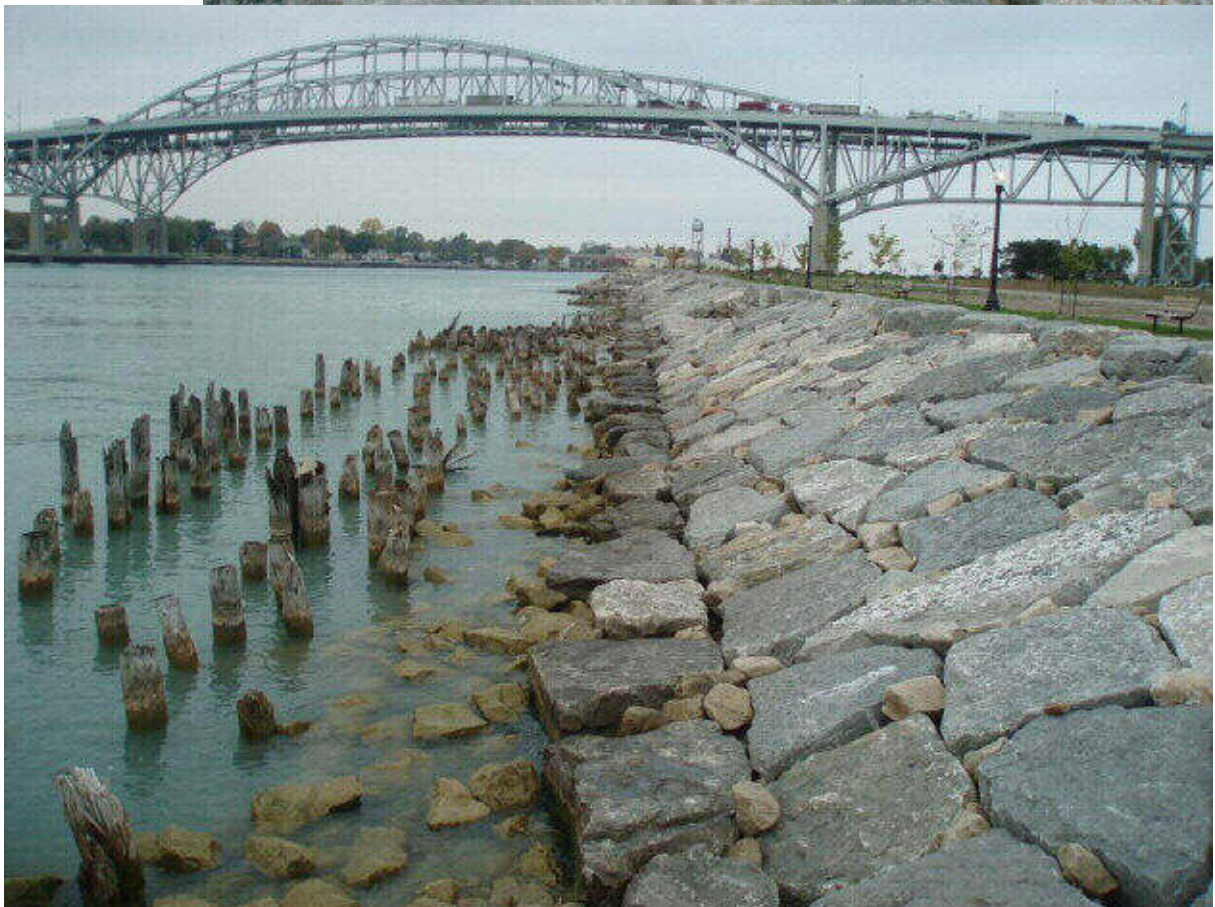
**After
Protection
Improvements**

Top – stepped
& sloped
armour stone
protection

Bottom –
shallow back
water area

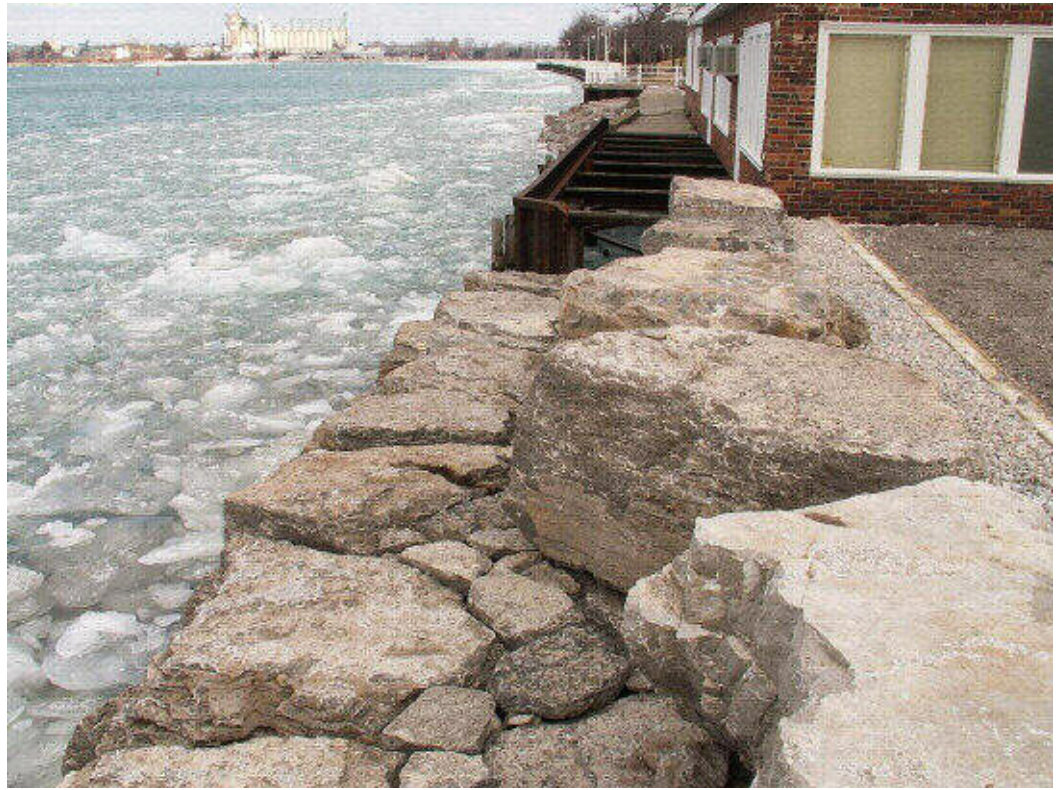
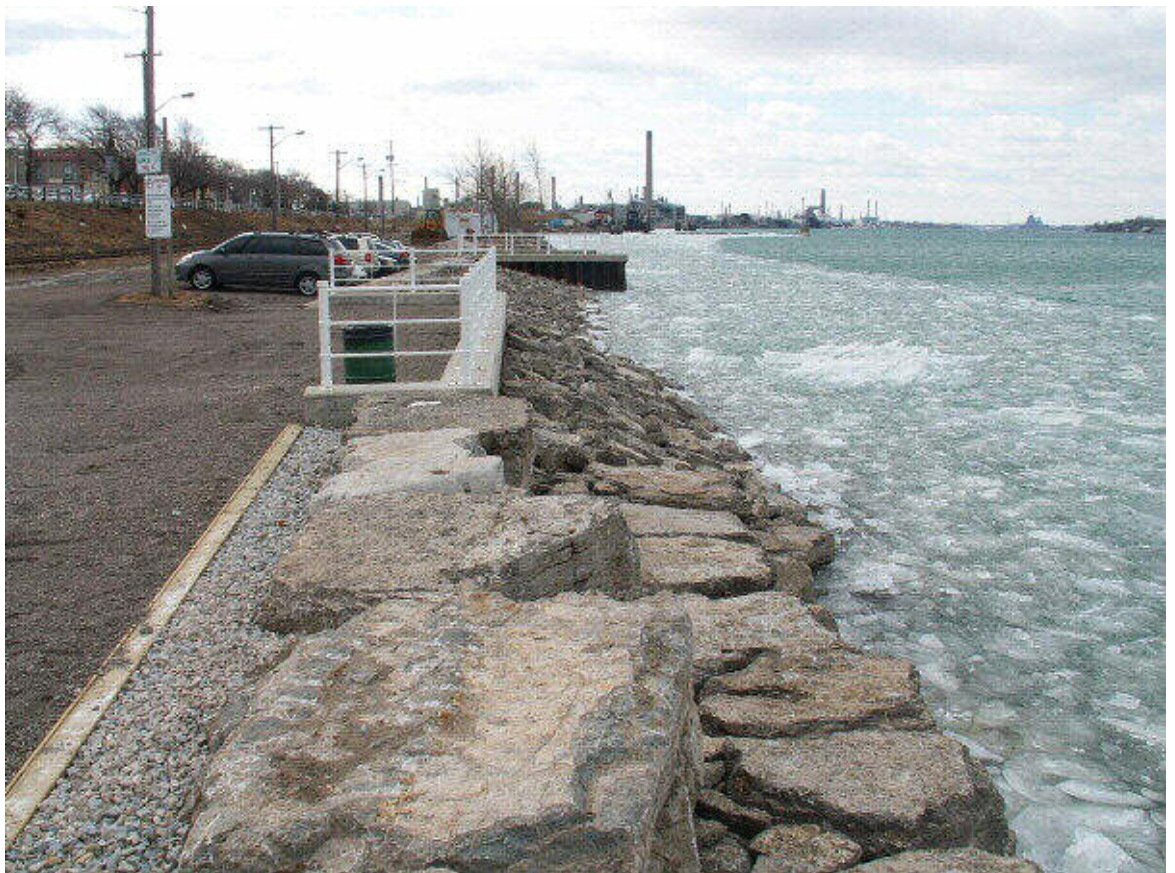
After Construction Completed

Top – stepped
armour stone
revetment

Bottom – stepped
armour stone
transitions to a
rip rap revetment
– railings added
to existing
seawalls to
provide handicap
accessible fishing
areas

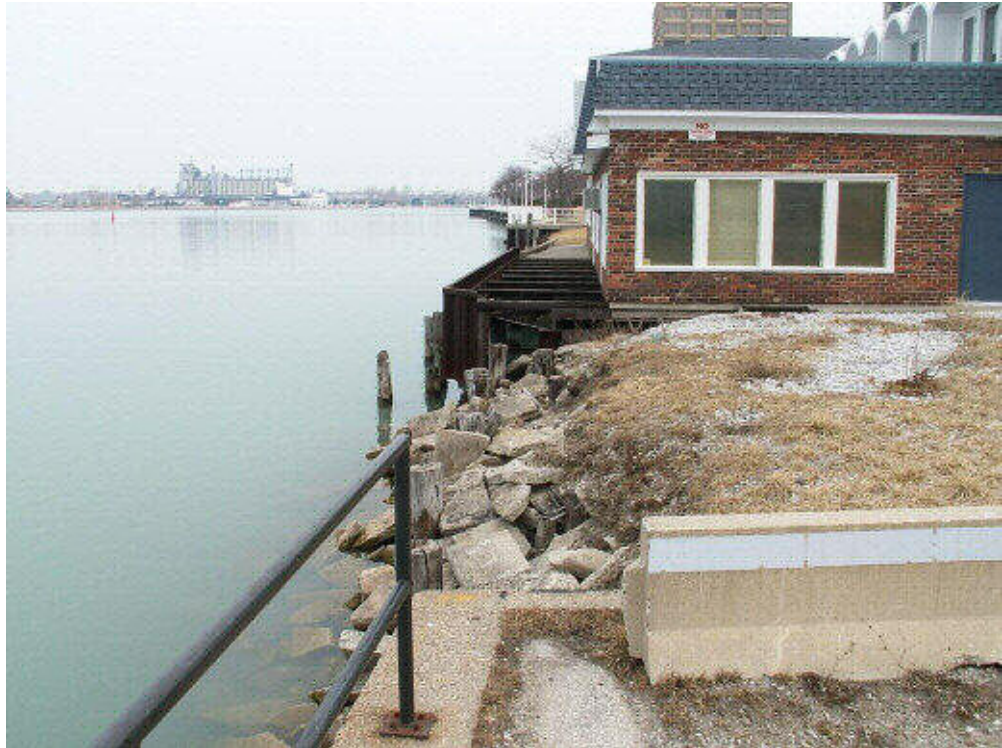
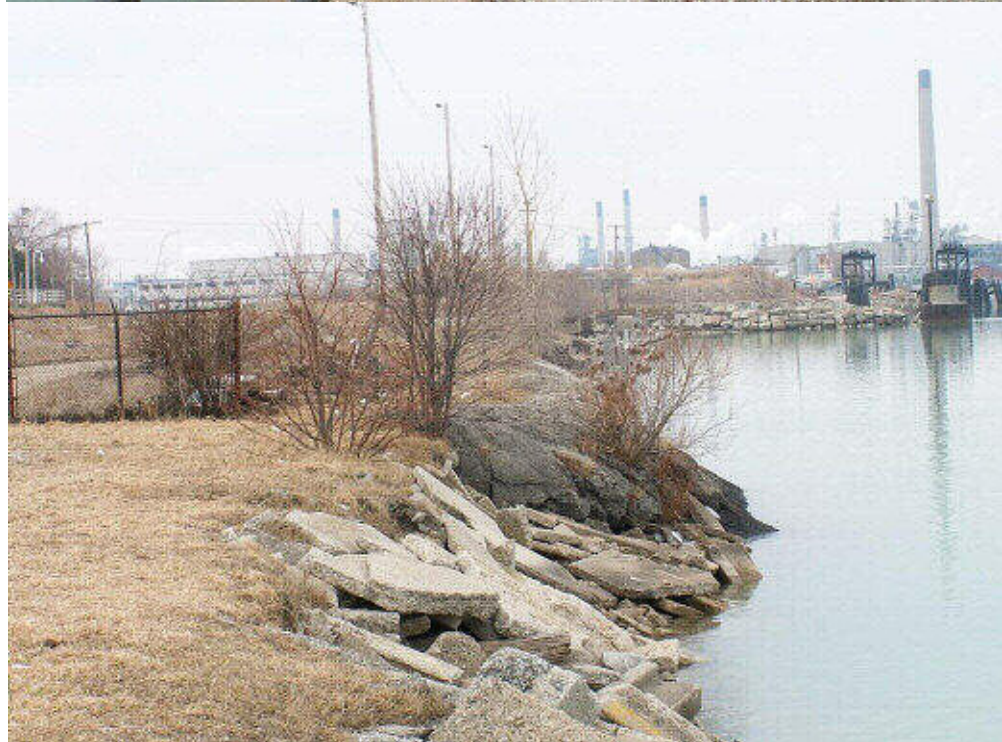
Mission Park Shore Protection Revitalization

**Prior To
Construction**

This shoreline work will be implemented in phases subject to available funding and necessity to replace severely damaged segments of the protection works. Phase 1 of this project is completed in 2008 and provided shoreline protection to about 115 m of St. Clair River shoreline. Phases 2, 3 and 4 are expected to provide shoreline protection to an additional 260 meters of St. Clair River shoreline.

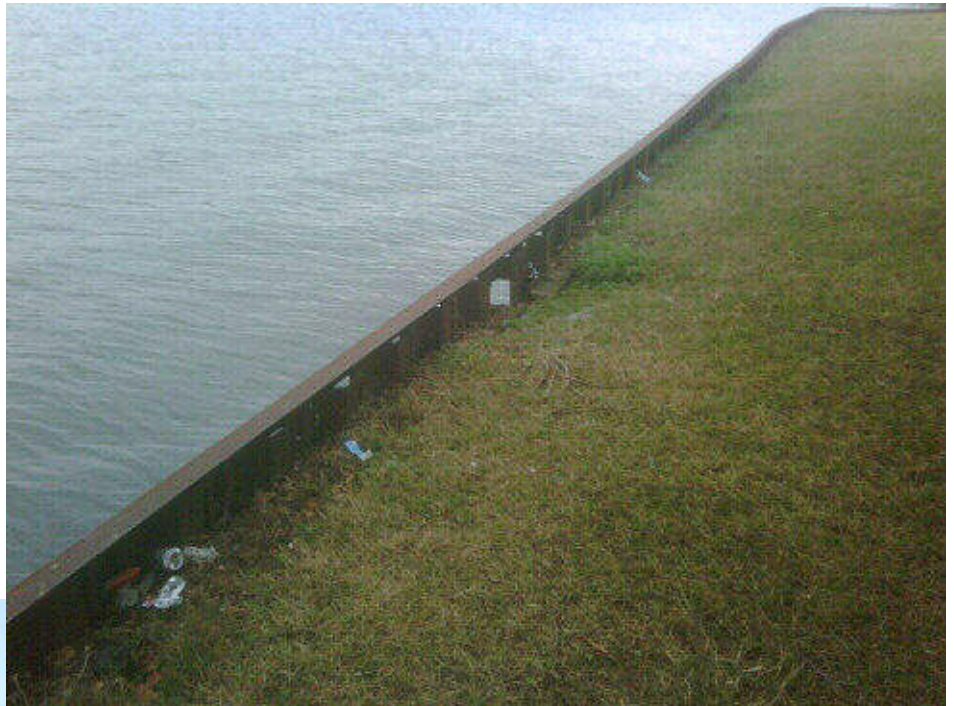
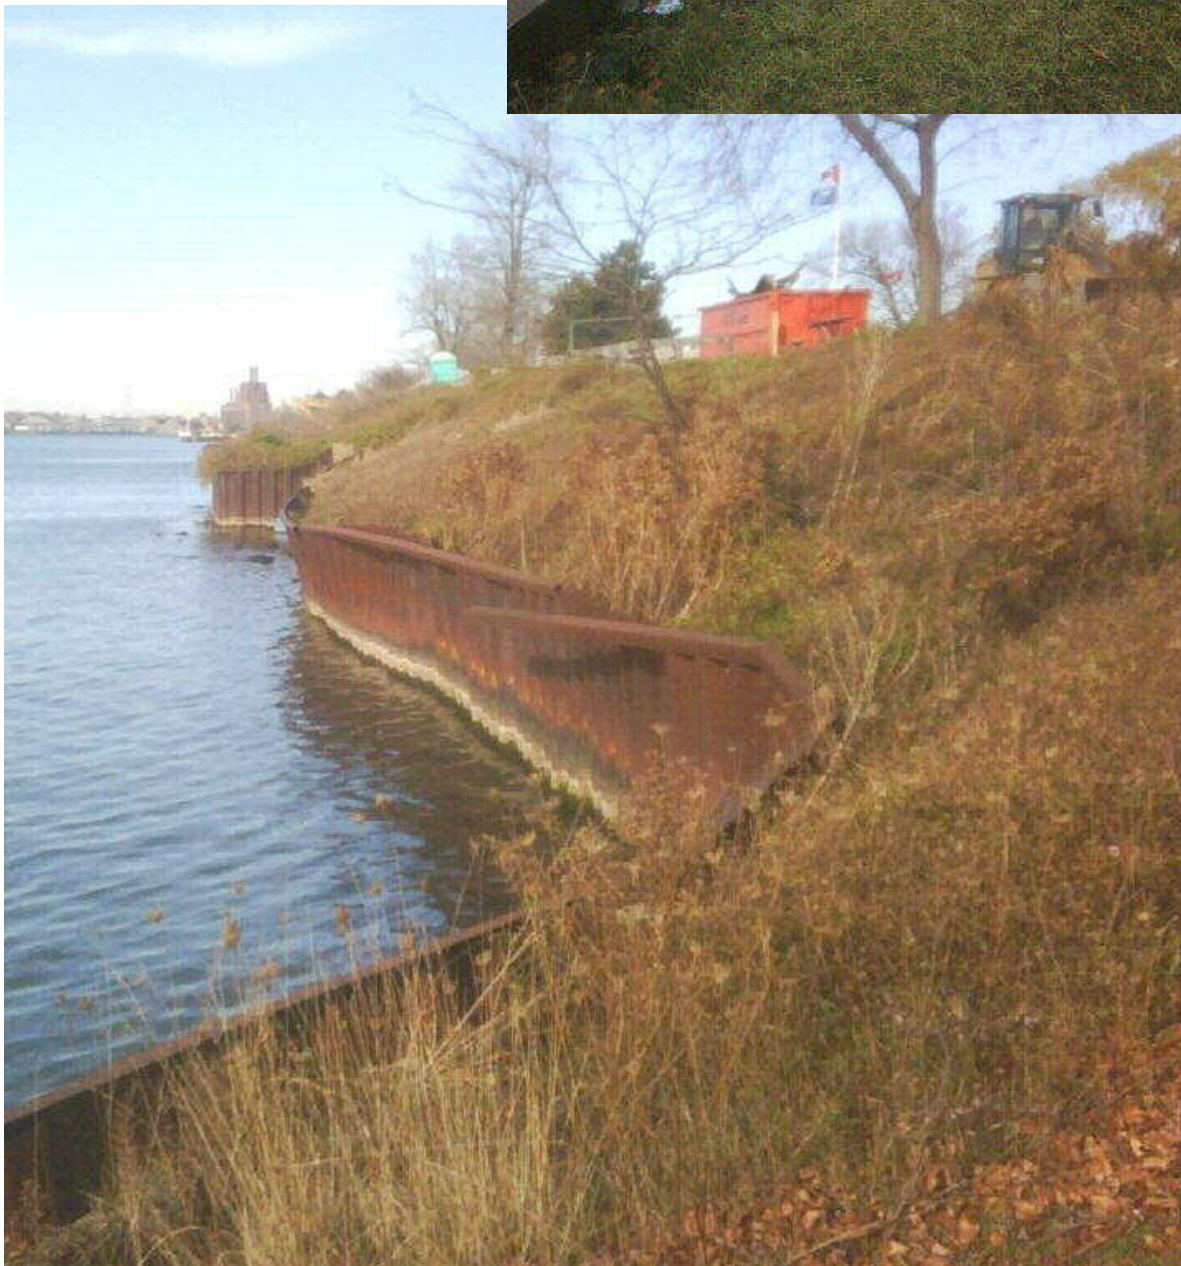
Guthrie Park Shore Protection Revitalization Project

**Prior to Protection
Improvements**

The work included removal of structures, supply and placement of rip rap, and armour stone revetment combining sloping rip rap sections with an armour stone cap and stepped sections, some of which include aquatic habitat beds. The structure also incorporates a rip rap slope or bedding below the toe armour stones in deep water areas for support. Approximately 700 metres of St. Clair River shoreline was revitalized between 2008 and 2011.

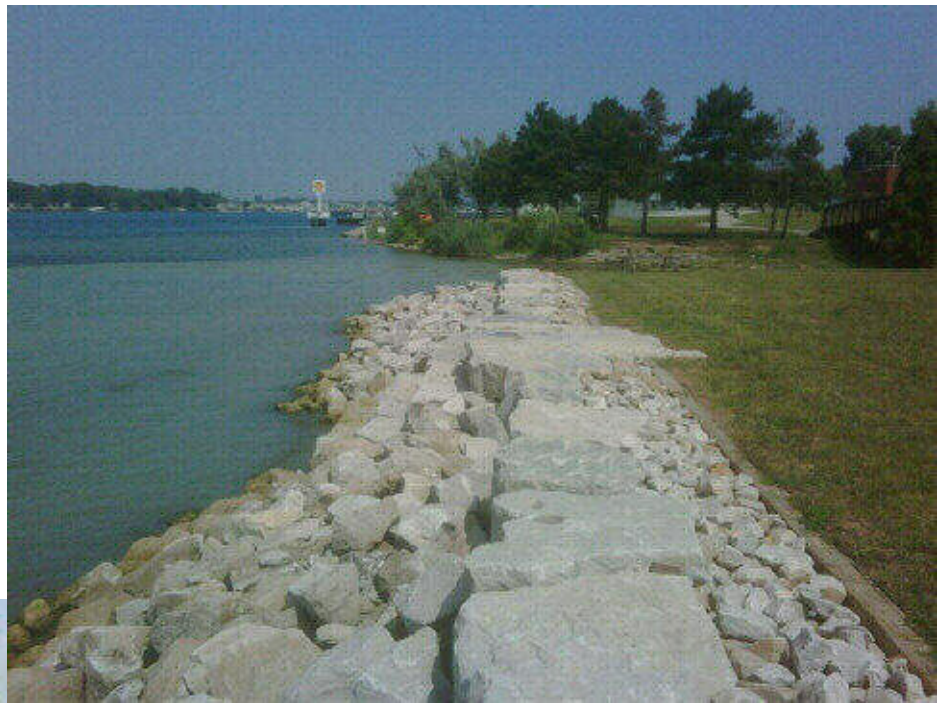
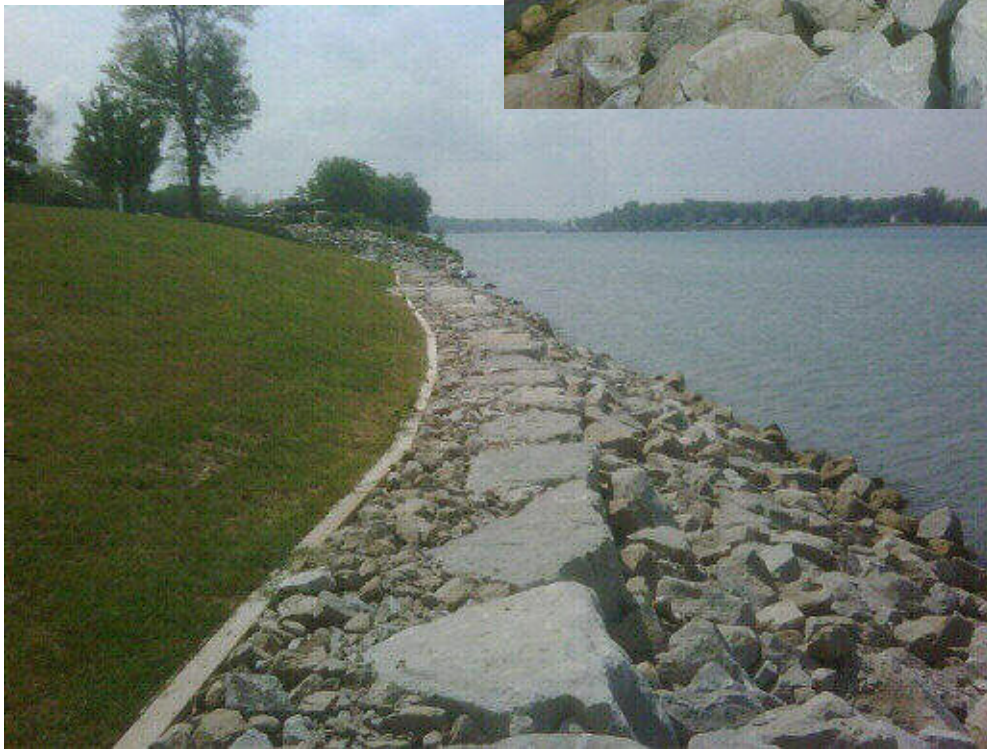
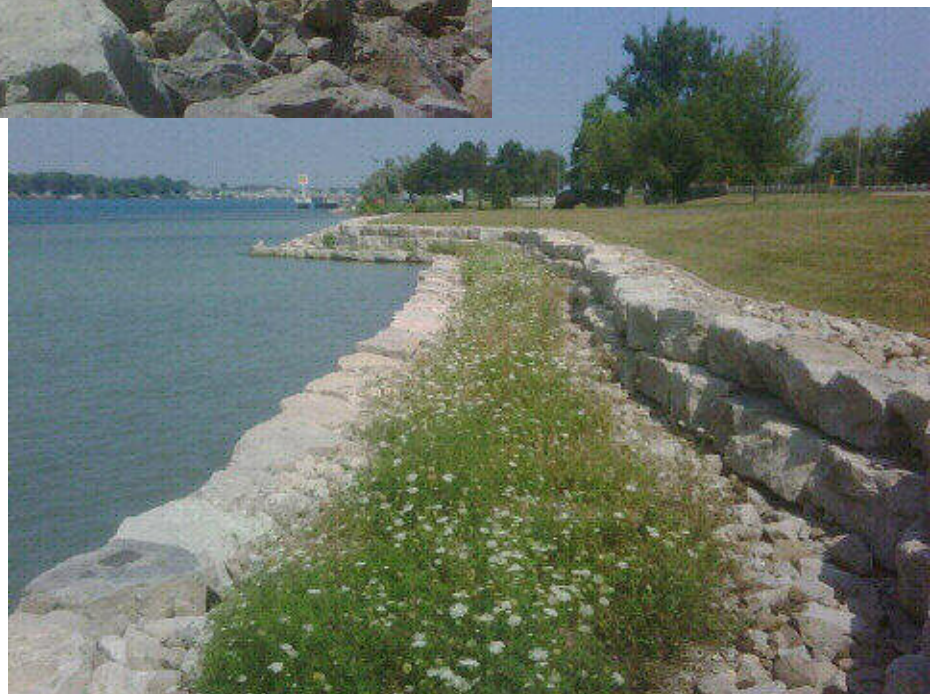
After Protection Improvements

Combination of stepped
armour stone and sloped rip
rap revetment.

Top – water's edge access
Middle – rip rap revetment
Bottom – armour stone with
habitat pod

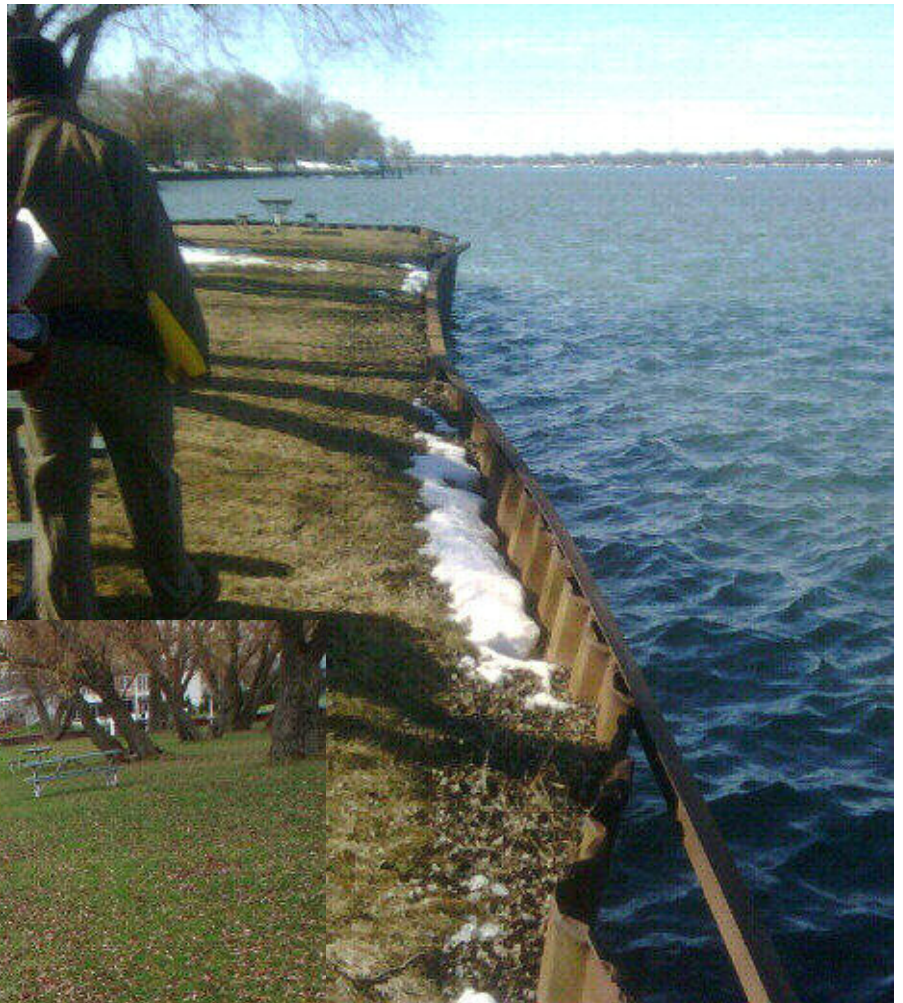
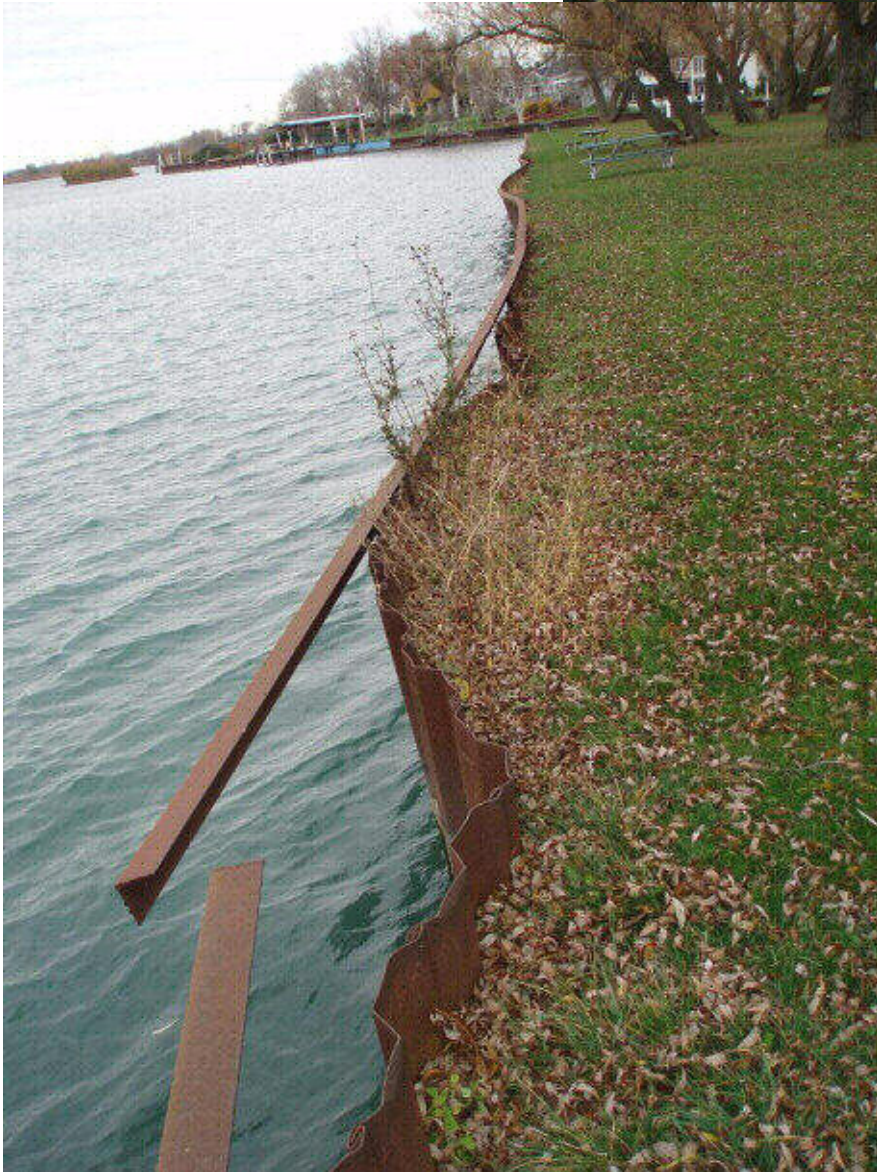
Cathcart Park Shore Protection Revitalization Project

Prior to Protection Improvements

This shoreline work will be implemented in phases subject to available funding and necessity to replace severely damaged segments of the protection works. The north end of the exposed west side of the park along the St. Clair River is the most damaged shore and is included in phase 1. Phase 1 of this project is completed in February 2012 and provided protection to about 150 m of St. Clair River shoreline.
