St. Clair River Shoreline Restoration Report

Table of Contents

1.0 Introduction

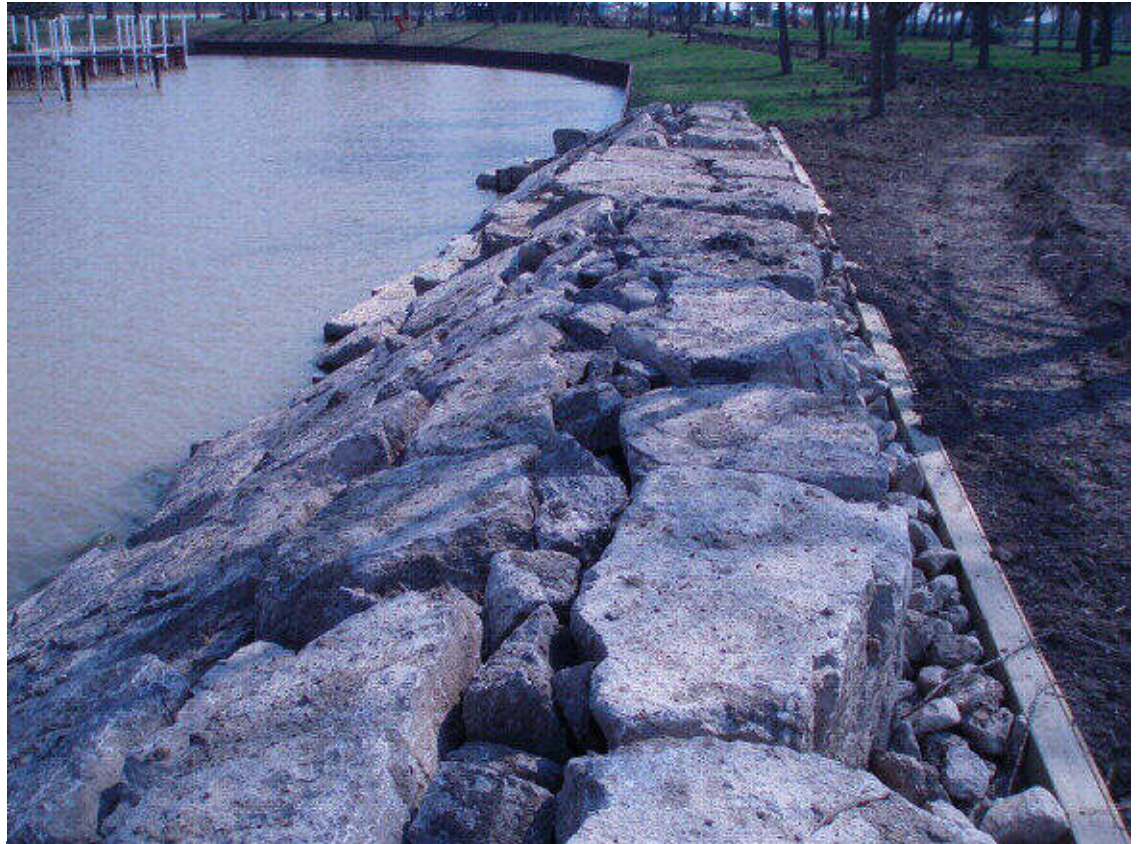
After Protection Improvements

Combination of stepped and sloped armour stone revetment.

Top – looking up
Clay Creek from
the St. Clair River

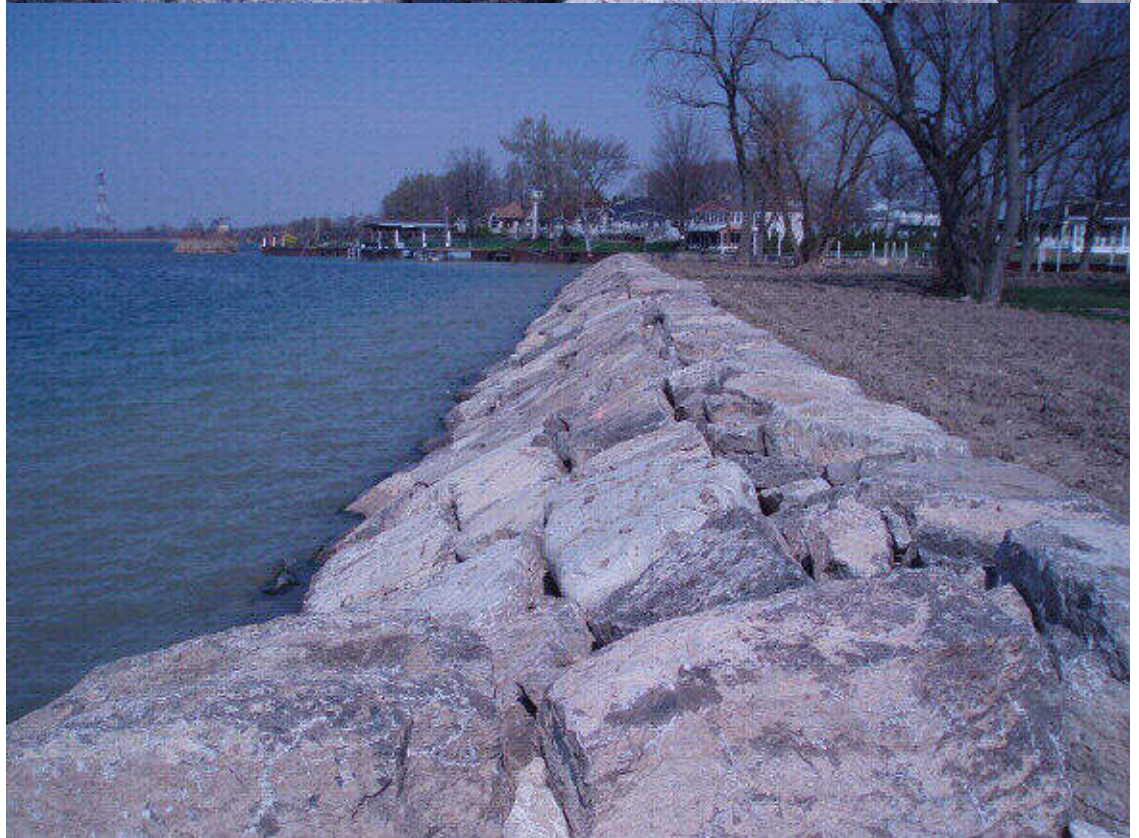
Bottom – looking
north along the
St. Clair River
