St. Clair River Shoreline Restoration Report

Table of Contents

1.0 Introduction

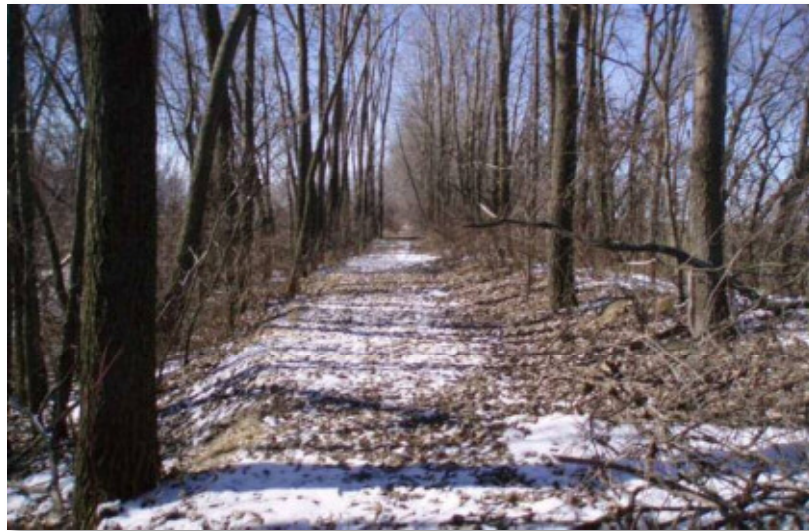
Figure 4 Dikes along Chenal Ecarte constructed to prevent flooding

Dikes covered almost **30%** of the shoreline, found mainly along the Chenal Ecarte and the northern sections of Lake St. Clair. These were designed and constructed to prevent flooding of low lying lands during flood events. Although presently, majority of them are in good condition, they have little to no bank protection on the slope facing the water which will decrease their life span. Mature trees and hazard trees are also concerns when looking at the longevity of these dike systems.

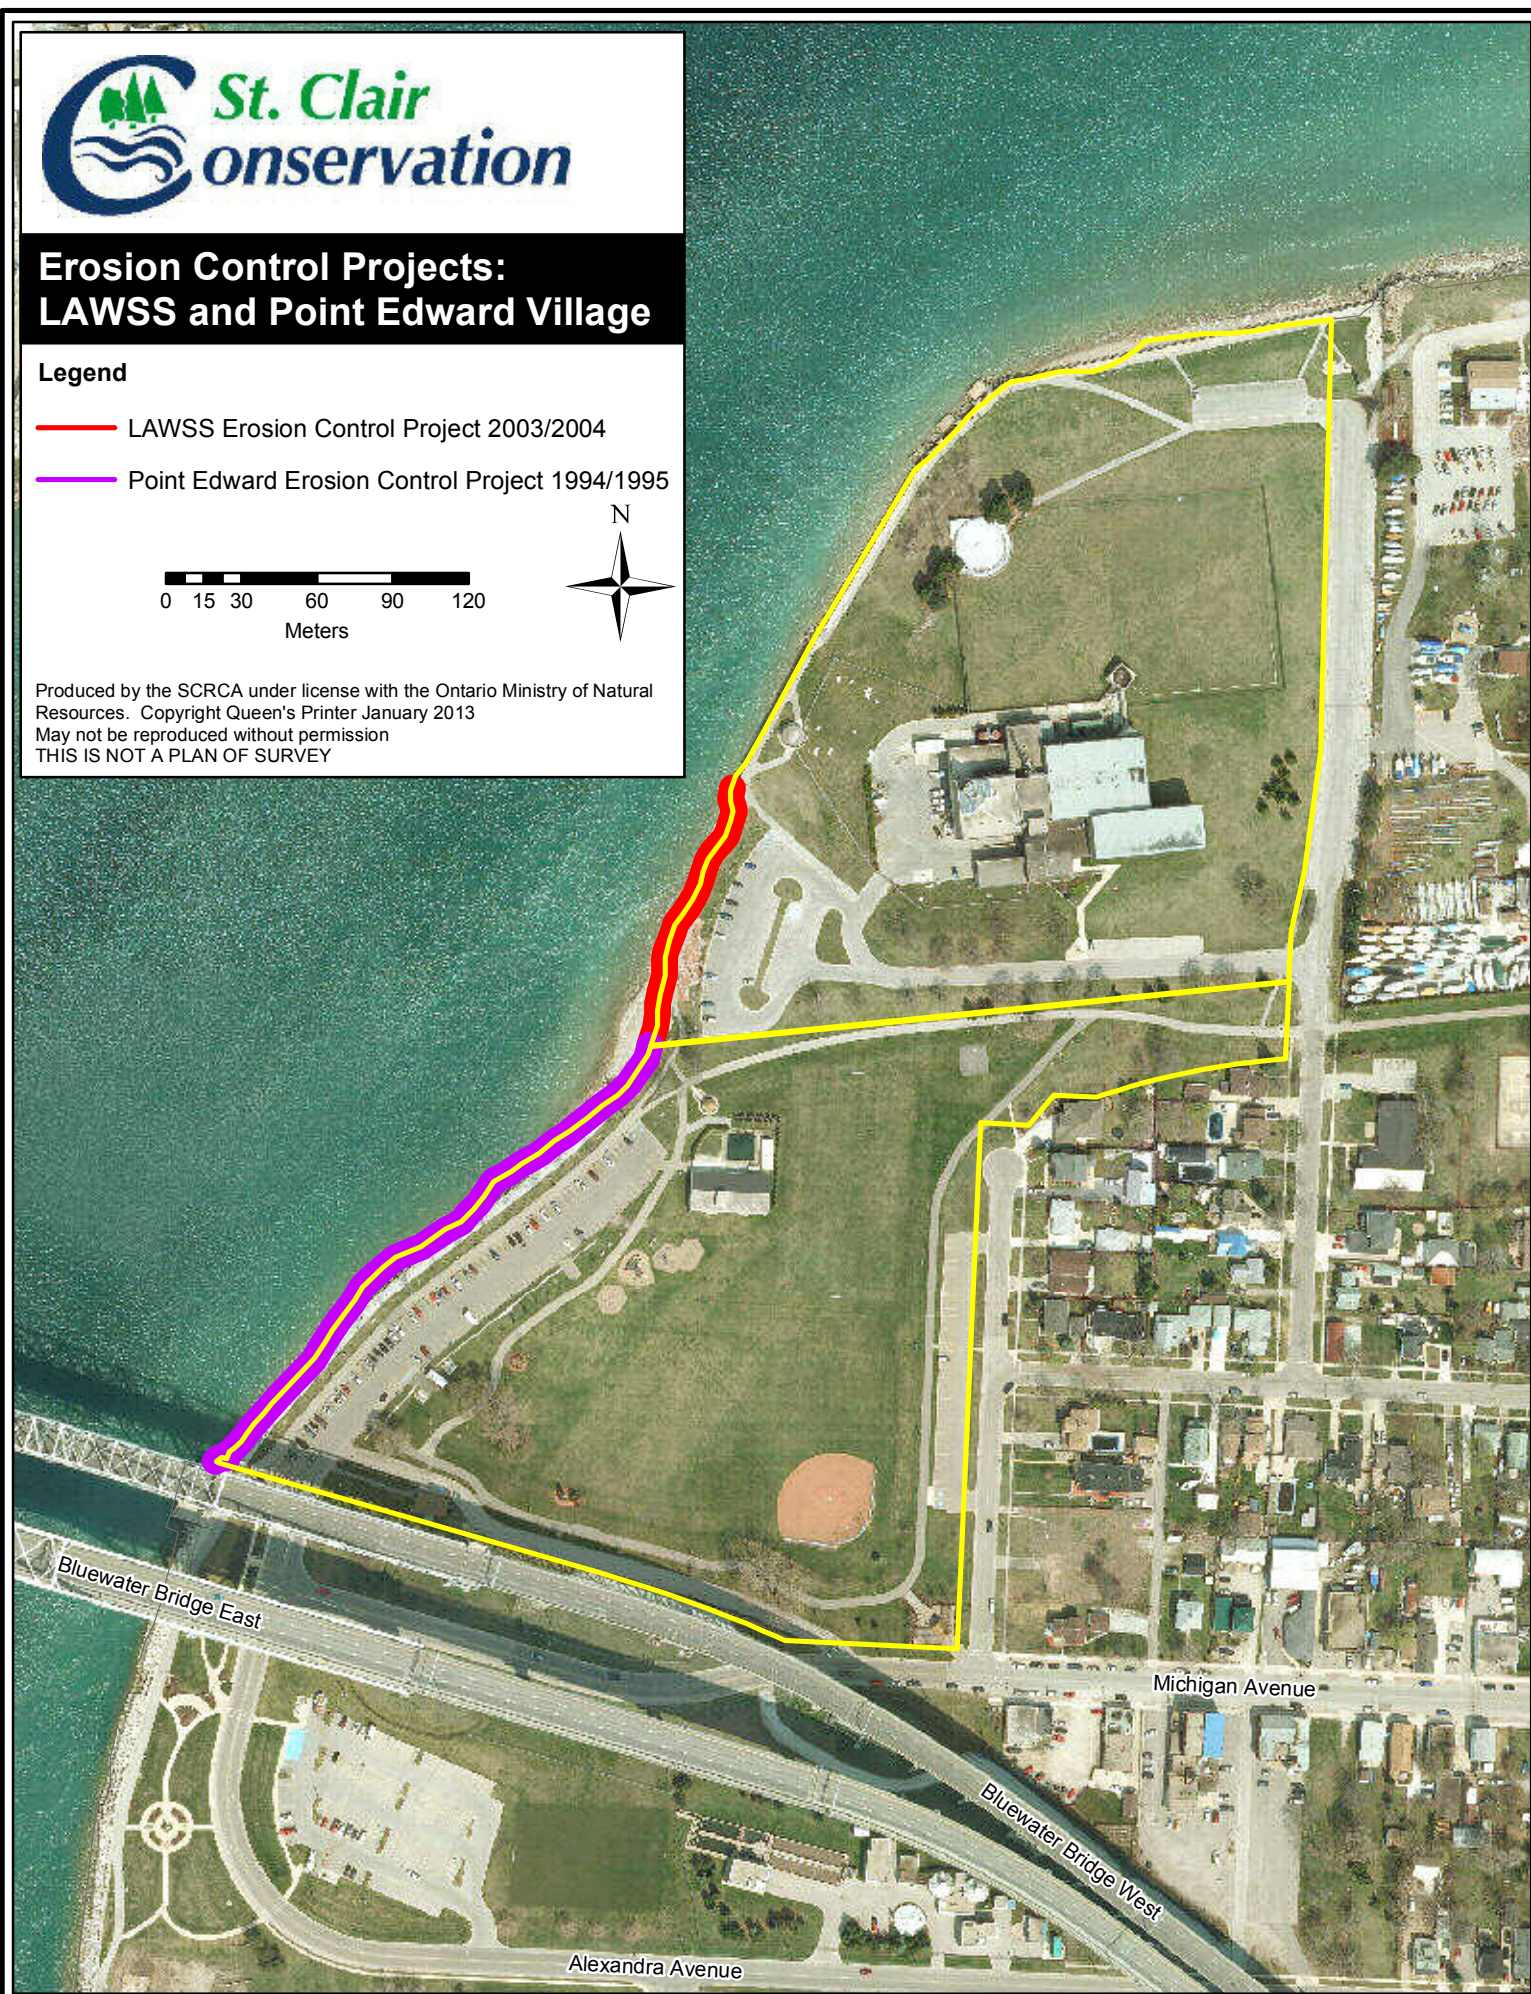
The work included removals of randomly stacked, discarded concrete, supply and placement of rip rap, armour stone and geotextile and other general site work associated with the construction of approximately 265 metres of a revetment and stepped revetment. Before and after construction pictures are provided below along with the location of the site.

The Point Edward Erosion Control Project was completed in 1995. This shoreline protection is located along the eastern shore of the St. Clair River just below the mouth of Lake Huron, along the waterfront of the Point Edward Waterfront Park. These shoreline works protect internationally significant parkland along the largest inland shipping channel in the world.
